Building Energy Efficiency for Massive market Uptake

Demonstration of Energy Efficiency through Retrofitting of Buildings

Deliverable D.3.9

Assessment of energy efficient performance and indoor environment in all 3 sites

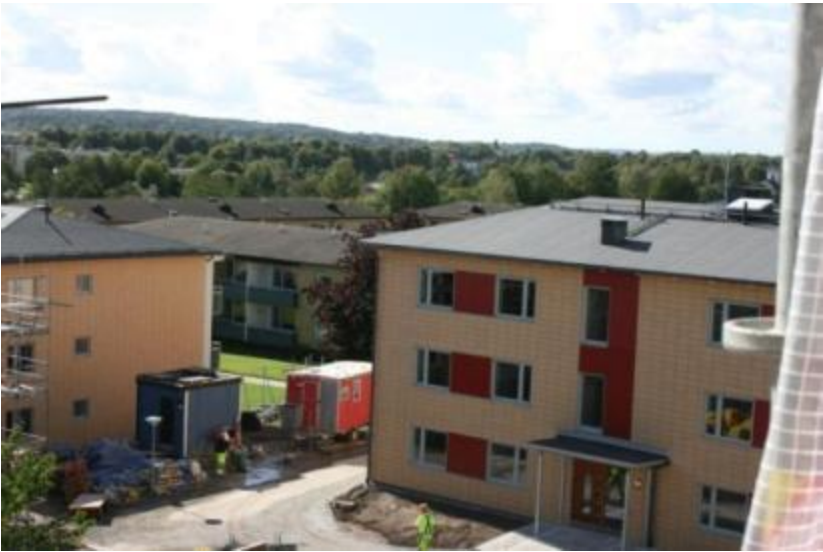
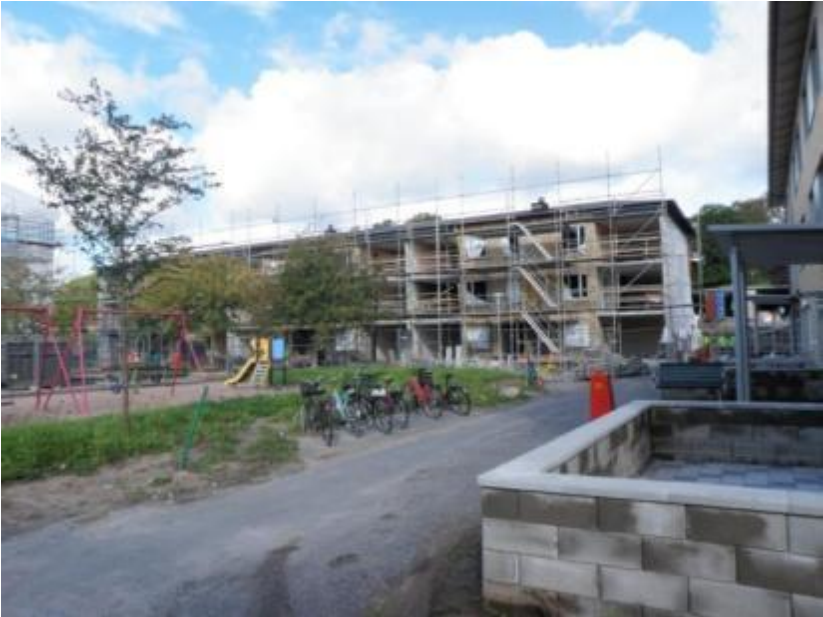
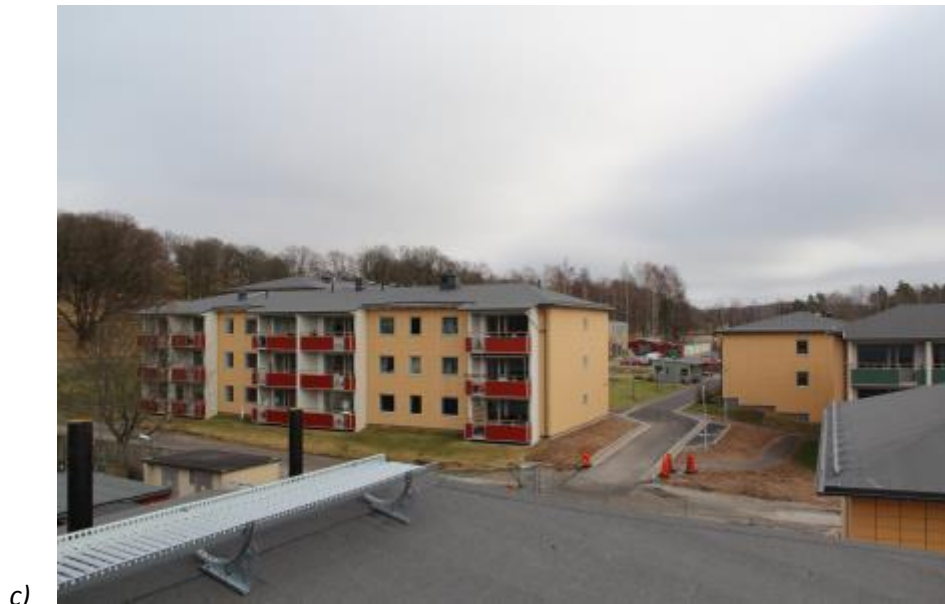
Figure 1: Pilot site in Alingsås

a) A renovated building in front of the photo, building that has not yet been renovated in the back.

b) House H during renovation.

c) Facades and roofs of buildings B, C, F, G and H as seen clockwise

Within the BEEM-UP project, one house has been selected for monitoring. The house holds 18 apartments on 3 floors and has a south facing façade. The size of the apartments varies from 1 to 4 rooms + kitchen per dwelling. The house is called “building H” within the BEEM-UP project. The monitoring of the building is done both on building level as well as more in detail for four of the apartments (see deliverable D 3.3, [1]). This building has also a shared laundry room. The following pictures show the renovated buildings as well as the House H during the renovation process in Alingsås.

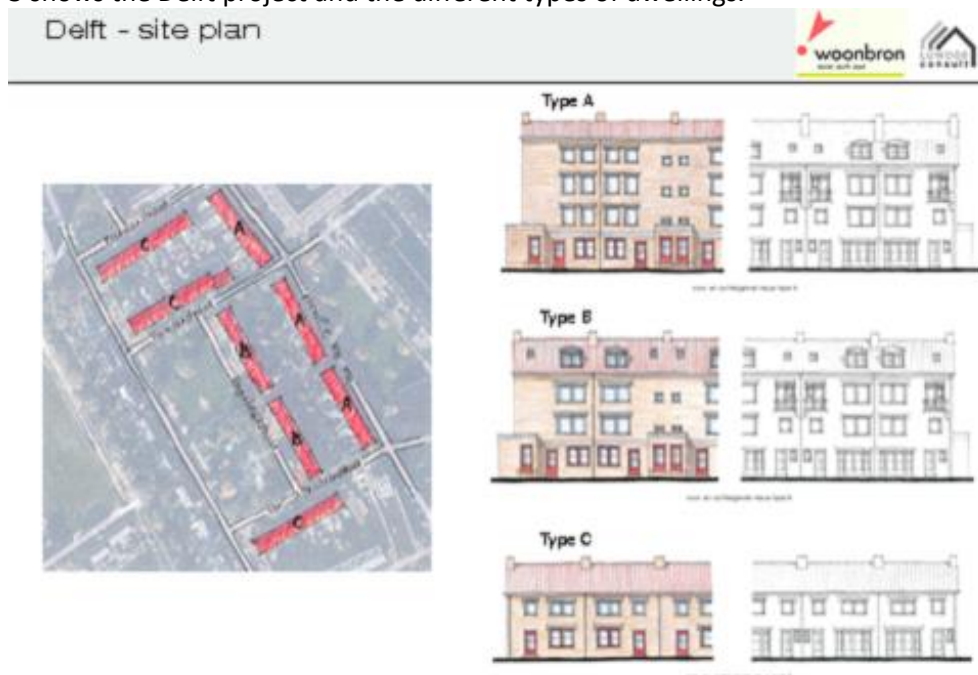
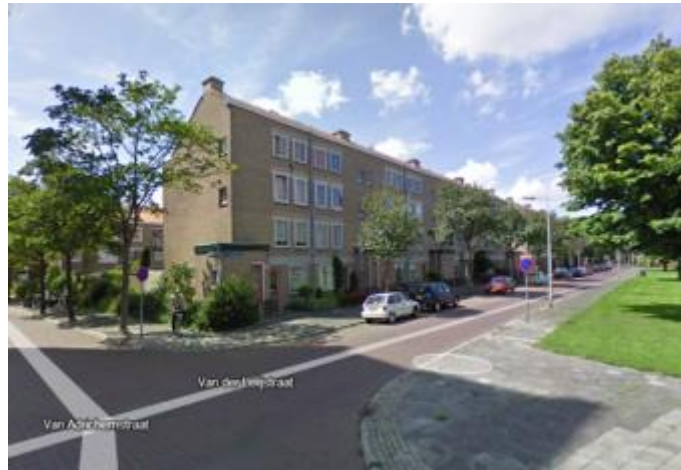
Figure 3: The Delft project has 3 types of houses in 8 blocks.

The Figure 3 shows the Delft project and the different types of dwellings.

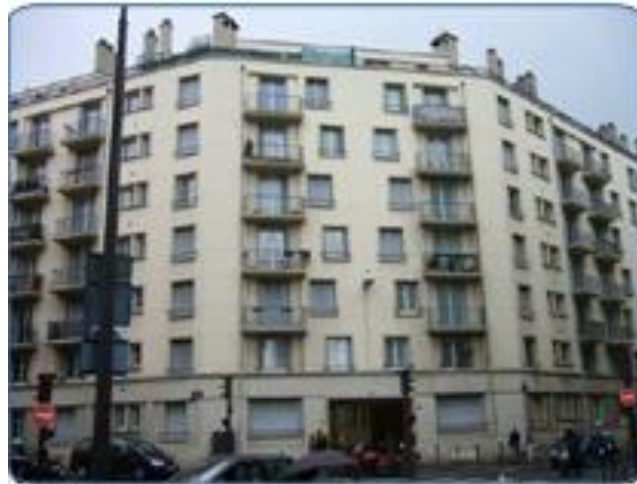
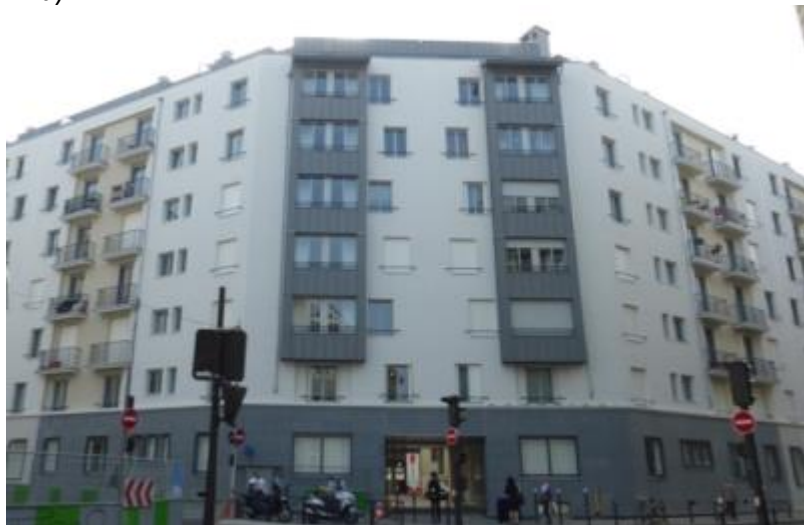
Figure 5: Pilot site in Paris

- a) Façade view of the building in Paris before refurbishment
- b) Façade view of the building in Paris after the refurbishment

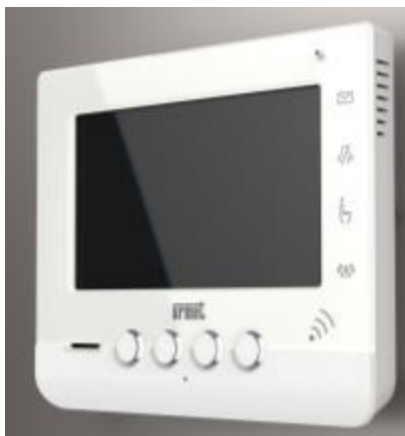
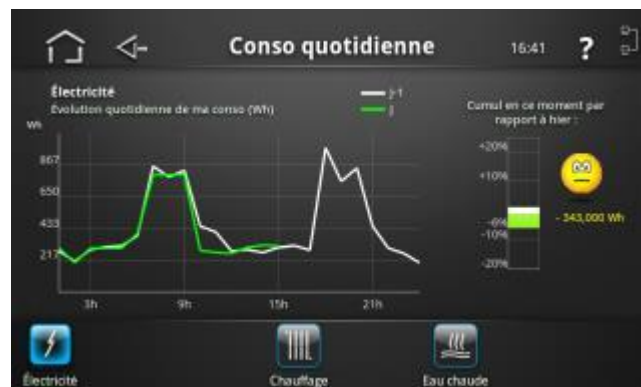
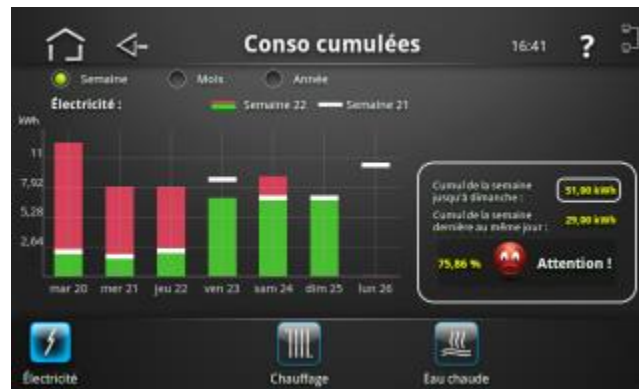
Figure 6: Examples of displays used in the feedback system installed in Paris site

In Paris, the energy feedback system is multifunctional including the door opener function (integrated in a videophone service) as well as the display of energy consumptions (Figure 6). Data on daily consumption as well as on accumulated consumption is available on the display. The system also enables the building owner NOVEDIS to communicate with the tenants. During the interviews, the feedbacks related to the feedback system are mitigated. Some of the tenants report that the functioning is not easy to handle. The thermostat seems not to be used by the tenants mainly because of the difficulty to use it in a simple way (lack of operating instructions). Whereas the individual thermostats attached to the radiators seem to be intensively used by the tenants, and that seems in good correlation with the indoor temperature management observed in the monitoring process [5].
